# **Five years of performance monitoring for a high flow biofiltration system at Western Sydney, NSW**

Ocean Protect webinar by Brad Dalrymple  
3<sup>rd</sup> August 2023

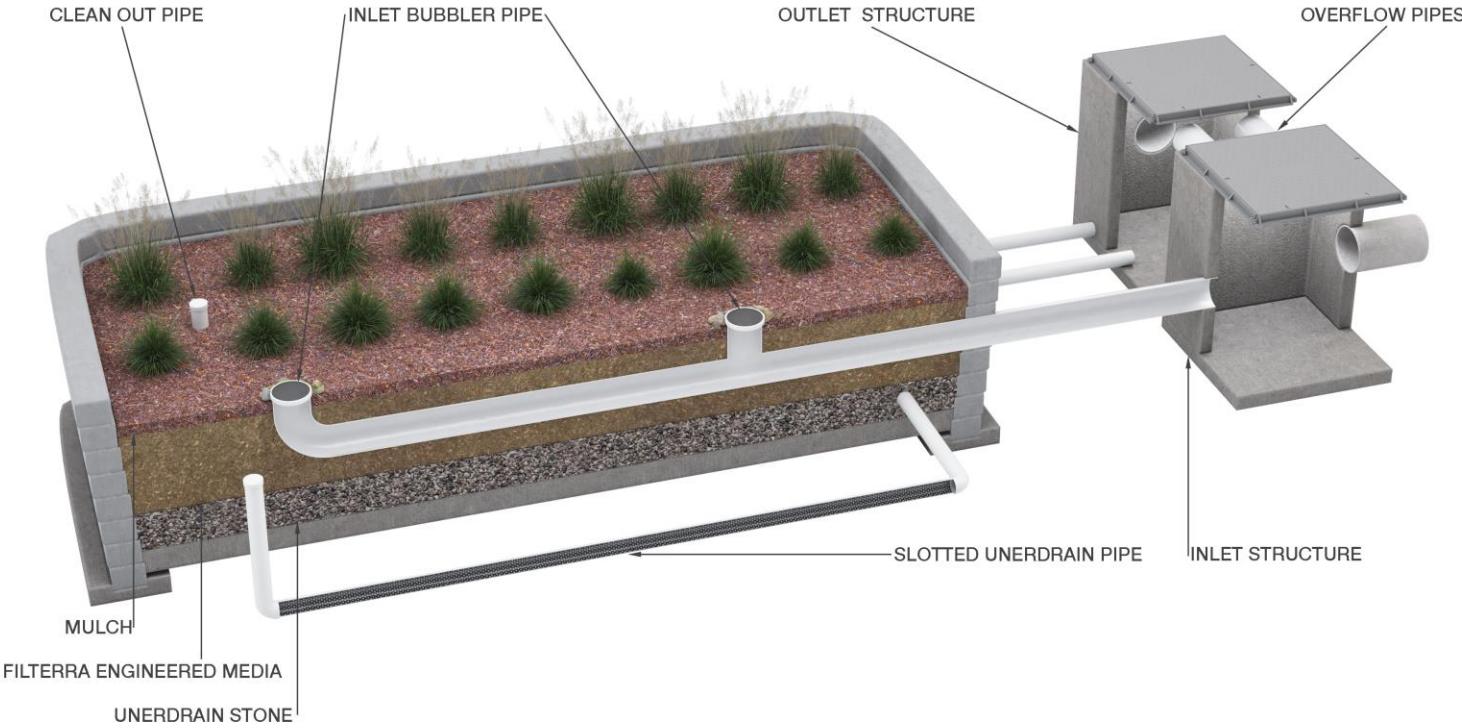
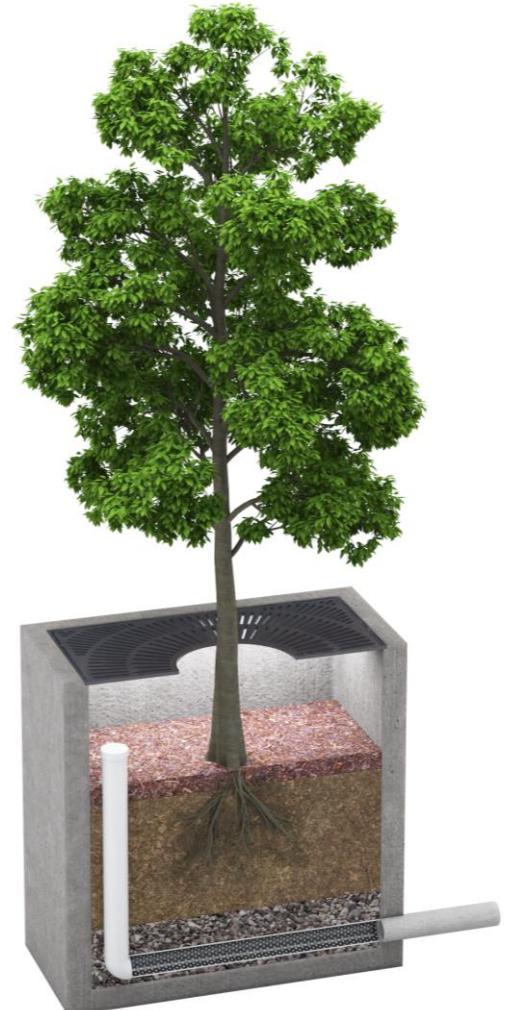
# What is Filterra ?

- ⌚ Just like 'conventional' bio, but smaller (& better)

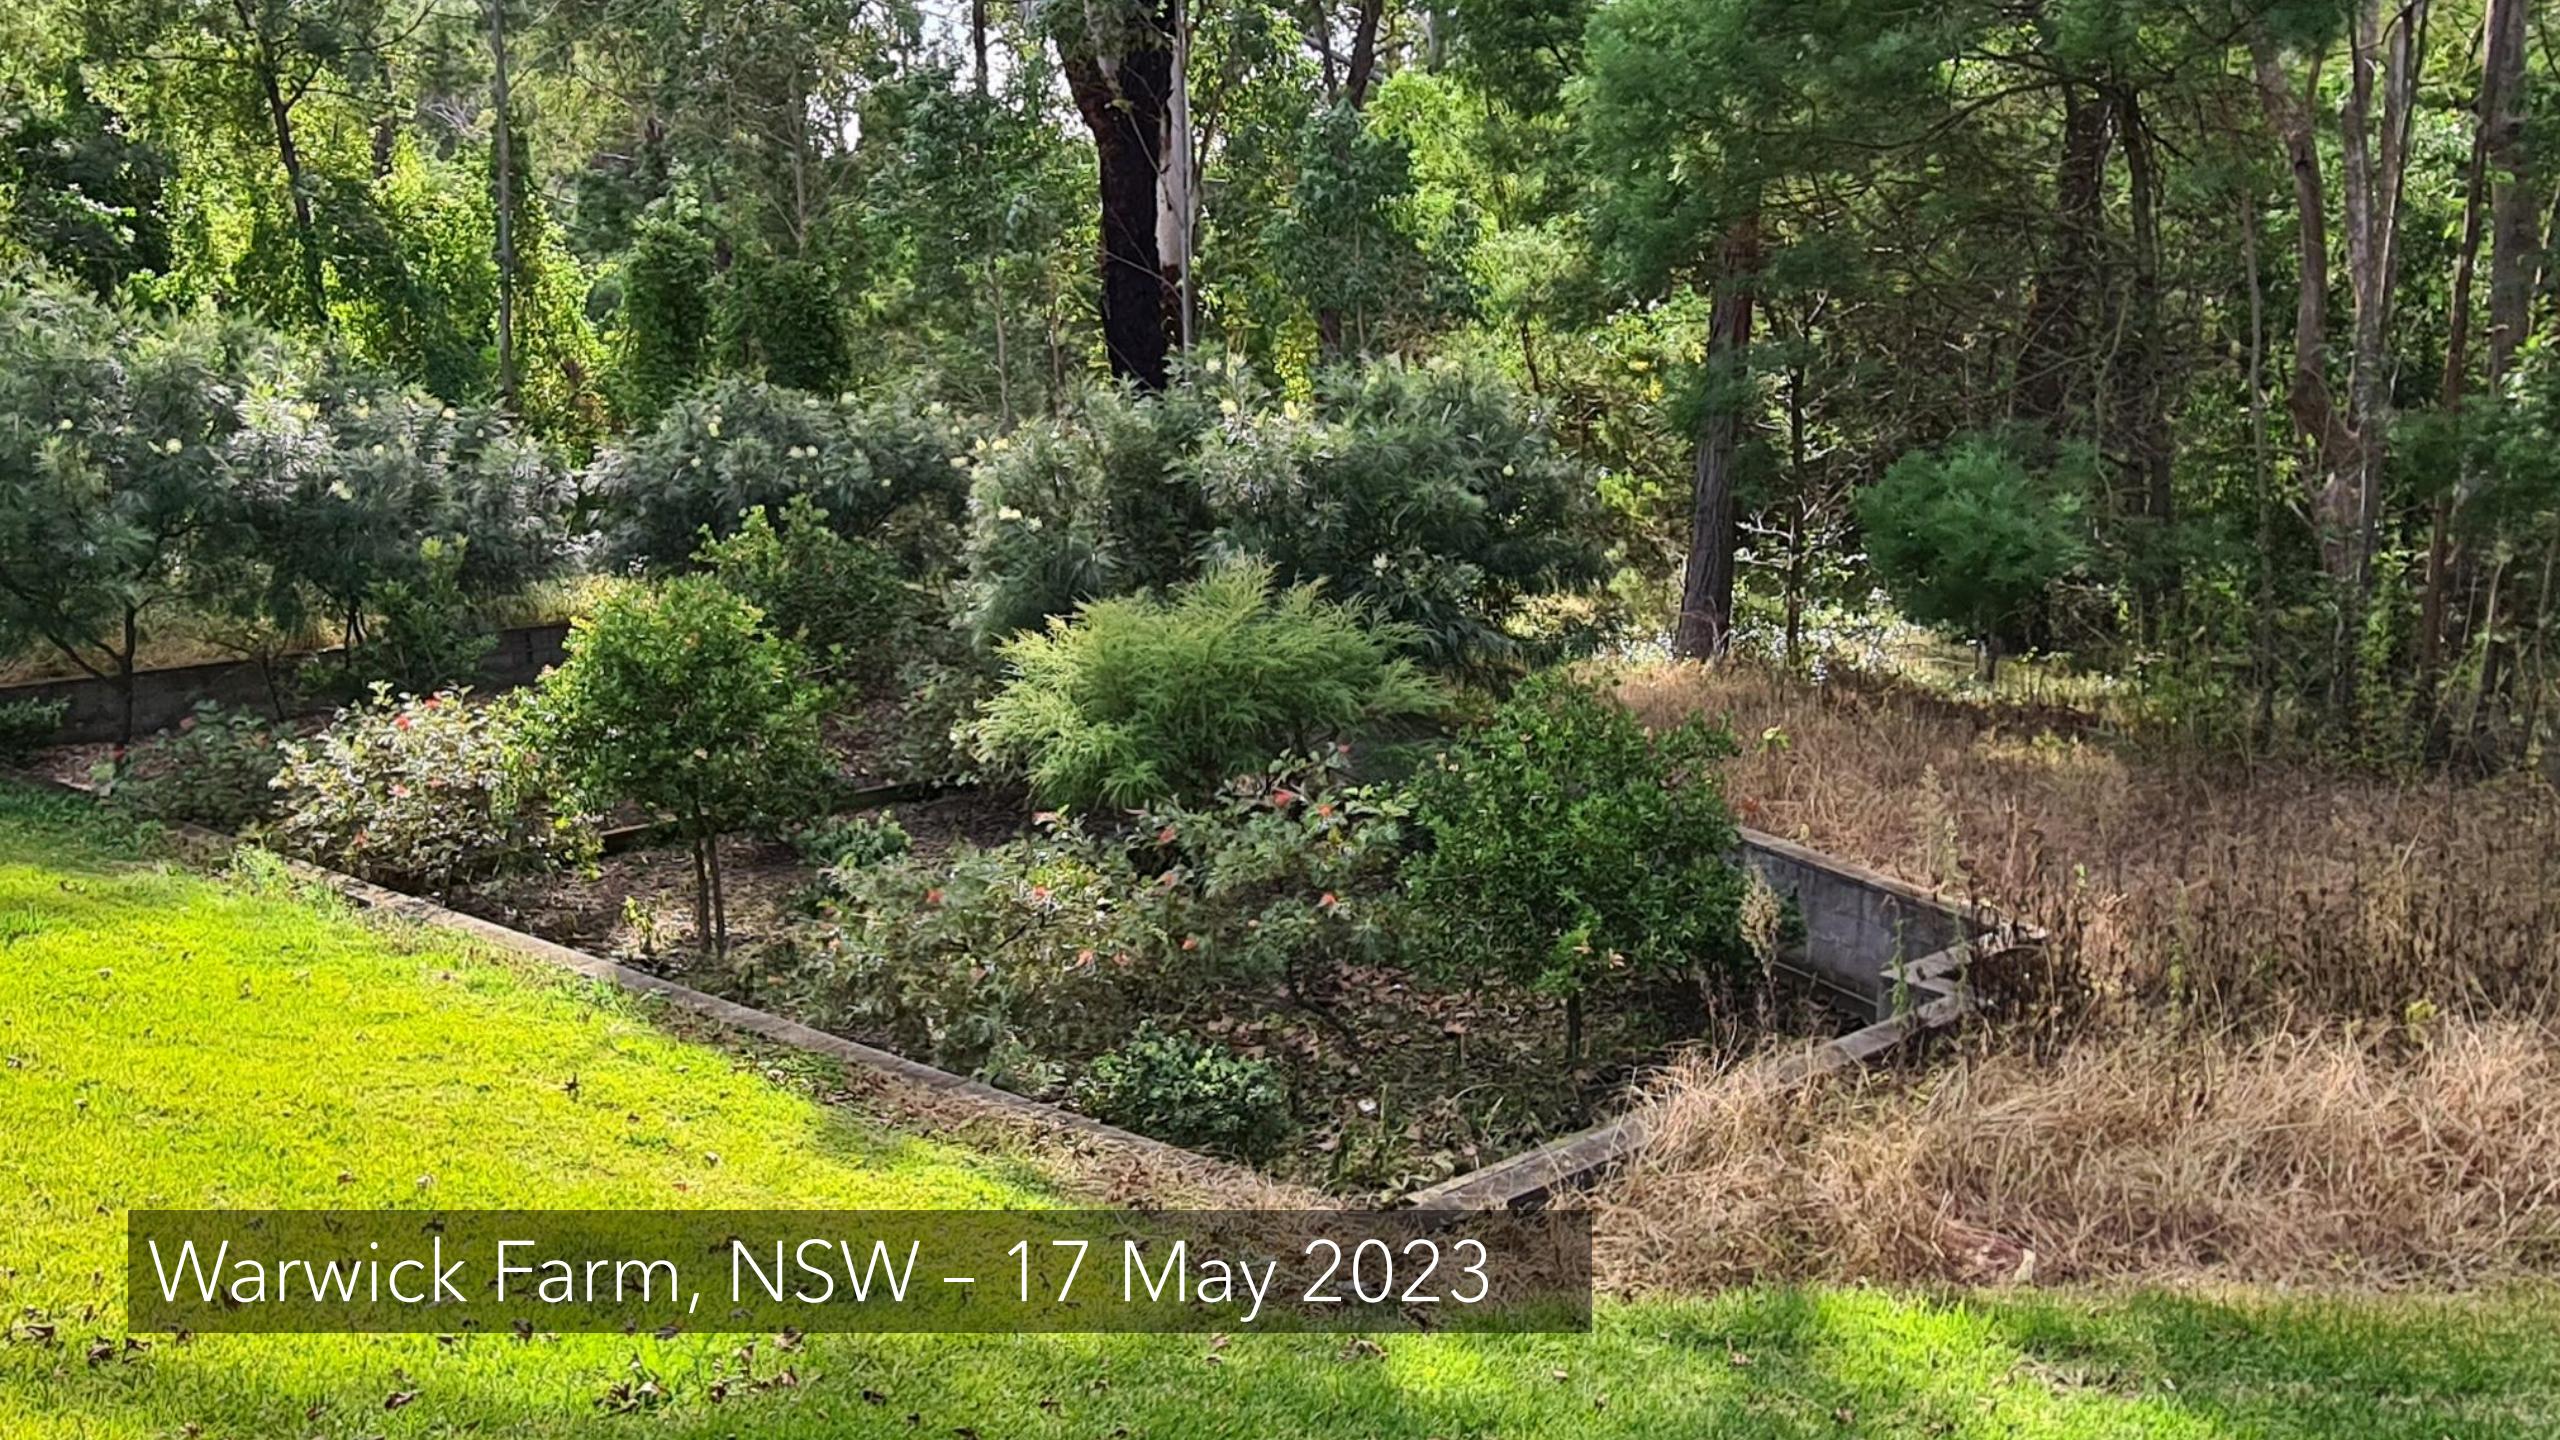
Warwick Farm, NSW - 17 May 2023

A photograph of a garden border. In the foreground, there is a strip of green grass. A wooden garden bed border runs along the edge of the lawn. Inside the border, there are several different types of plants, including a large green shrub, some smaller flowering shrubs with red flowers, and a tall evergreen tree. Behind the garden bed, there is a dense thicket of various bushes and trees, creating a lush green background.

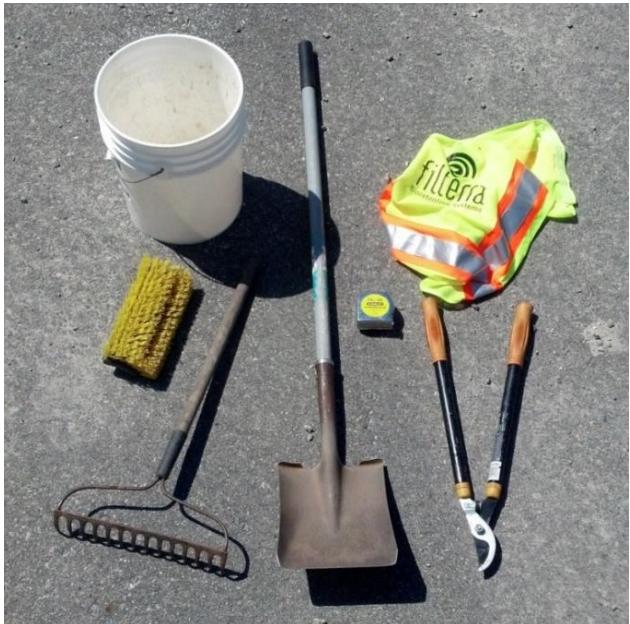
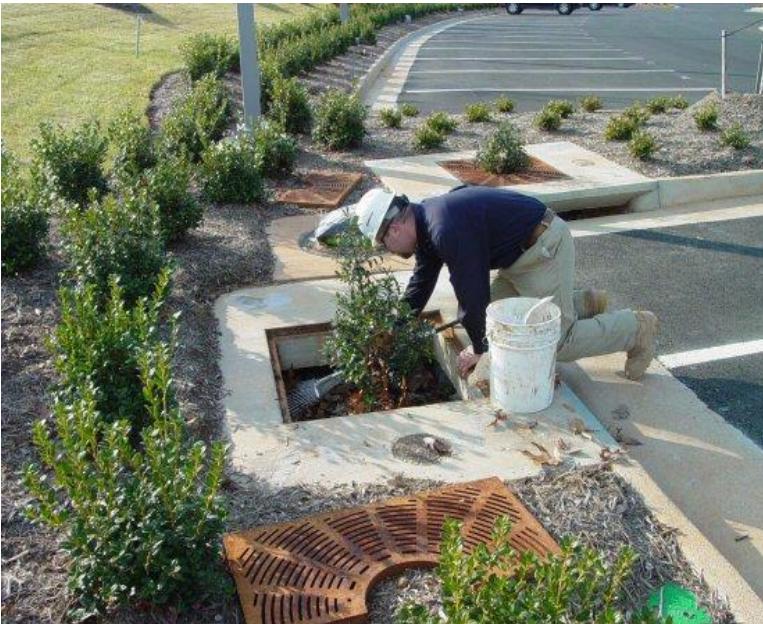
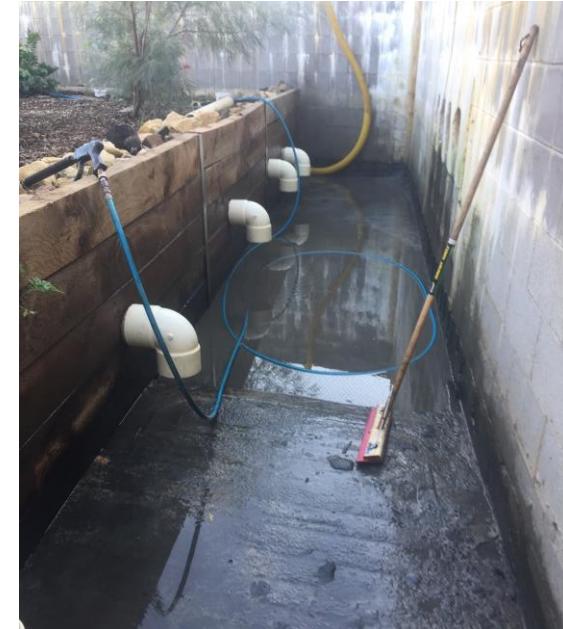
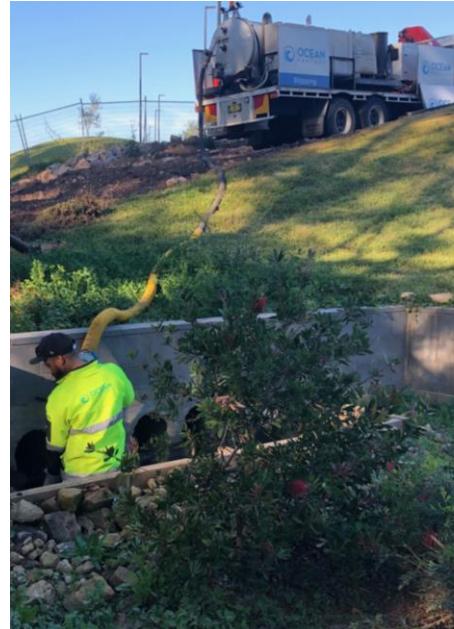
- ⦿ As per conventional bio **and** replace mulch every 6-18 months
- ⦿ Easy access
- ⦿ No specialized equipment needed
- ⦿ Sediment forebay clean-out (for bioscapes)

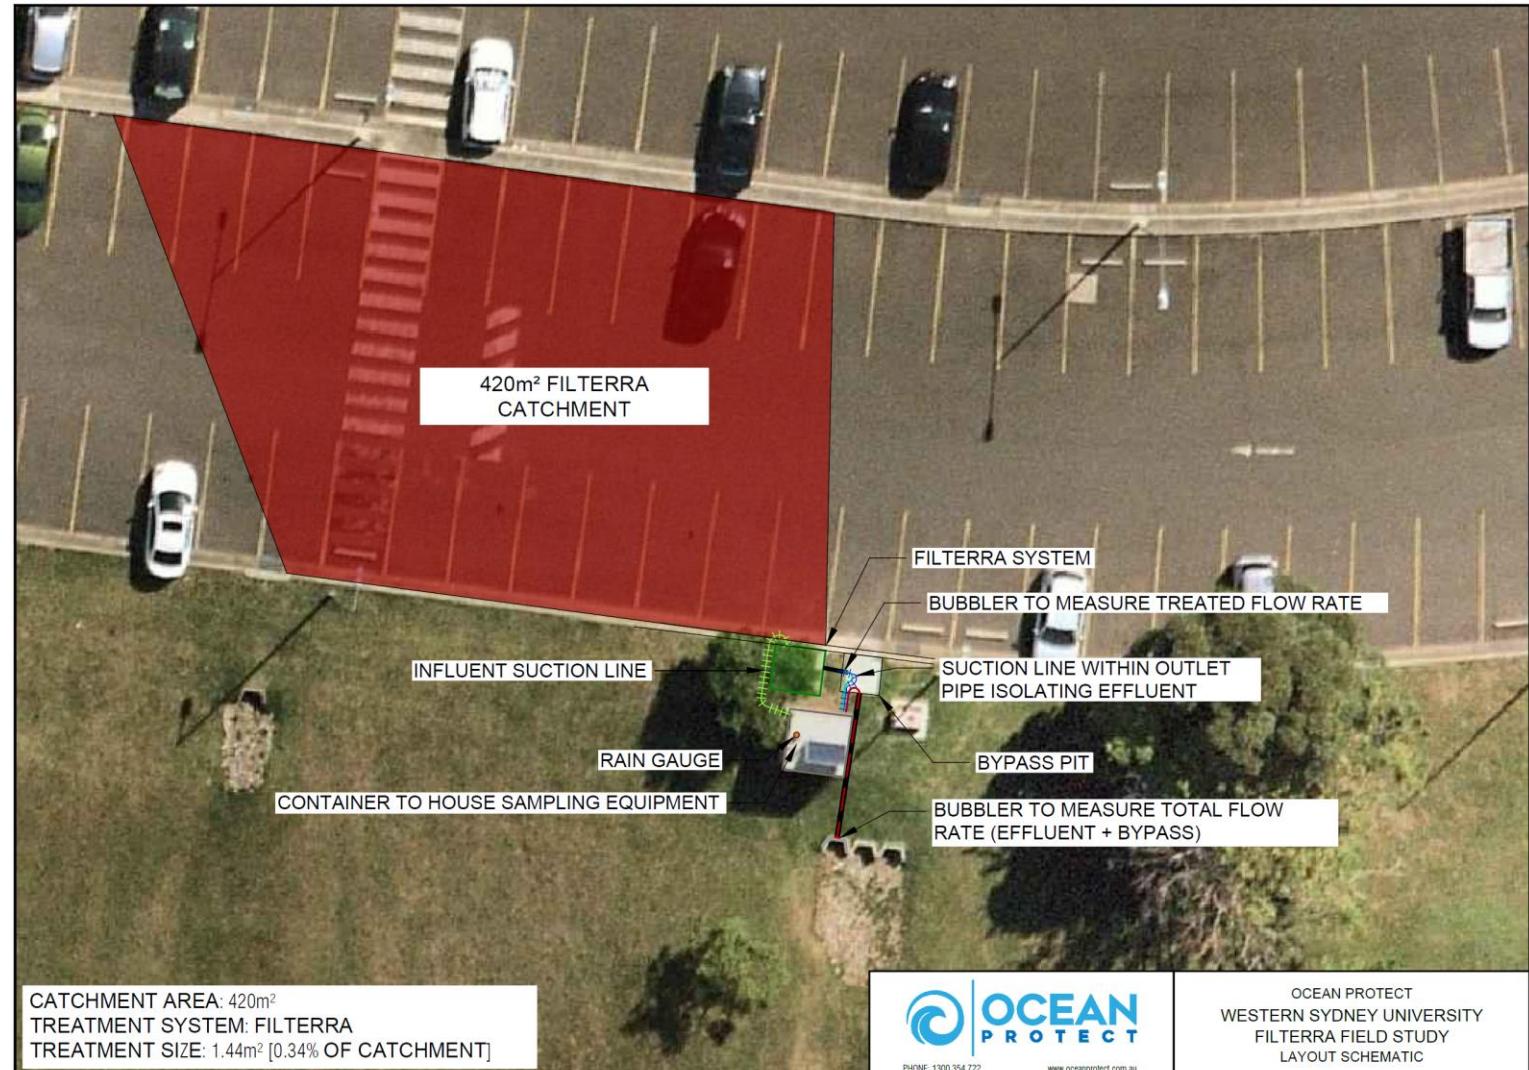
- 420m<sup>2</sup> car-park catchment
- 1.44m<sup>2</sup> Filterra bioretention
  - 0.34% of catchment area
  - Typical maintenance activities

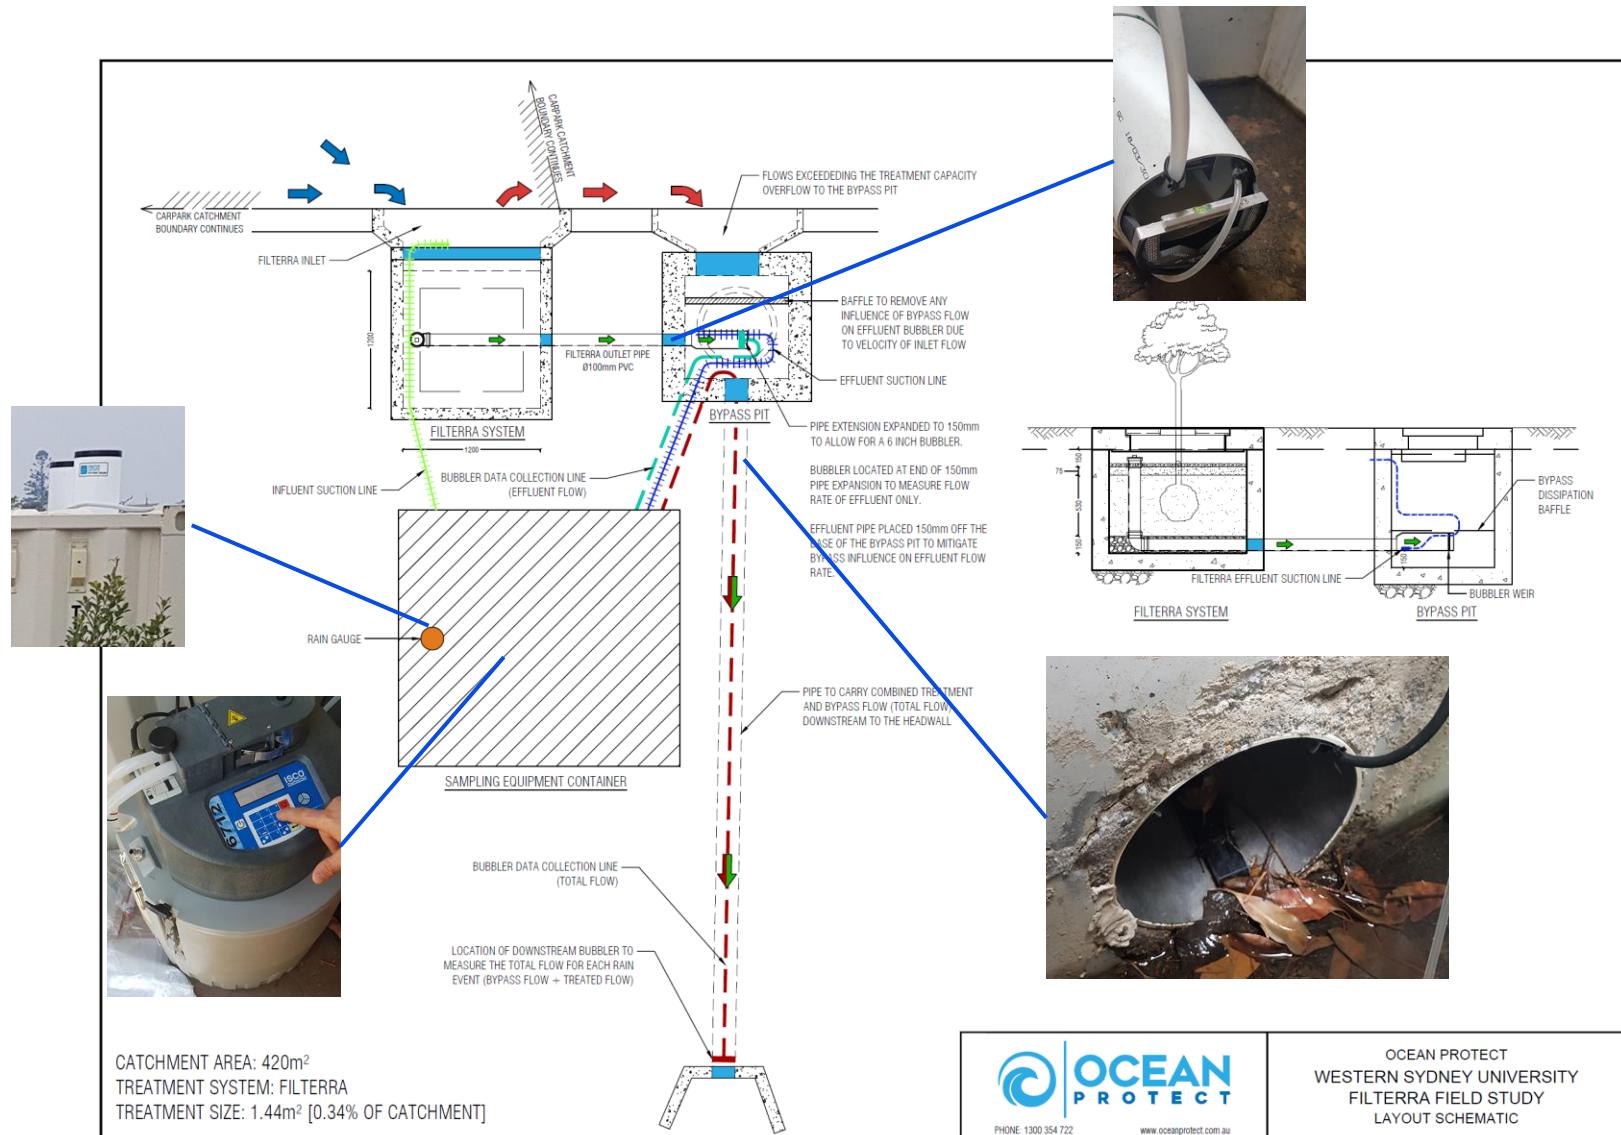
- ⦿ Flow & rainfall measurement
- ⦿ Automated sampling
  - Inlet & outlet
  - Flow proportional
  - Frequency programmed remotely
- ⦿ Samples
  - Collected by Ocean Protect, ALS, Western Sydney University & SESL
  - Analysed by ALS

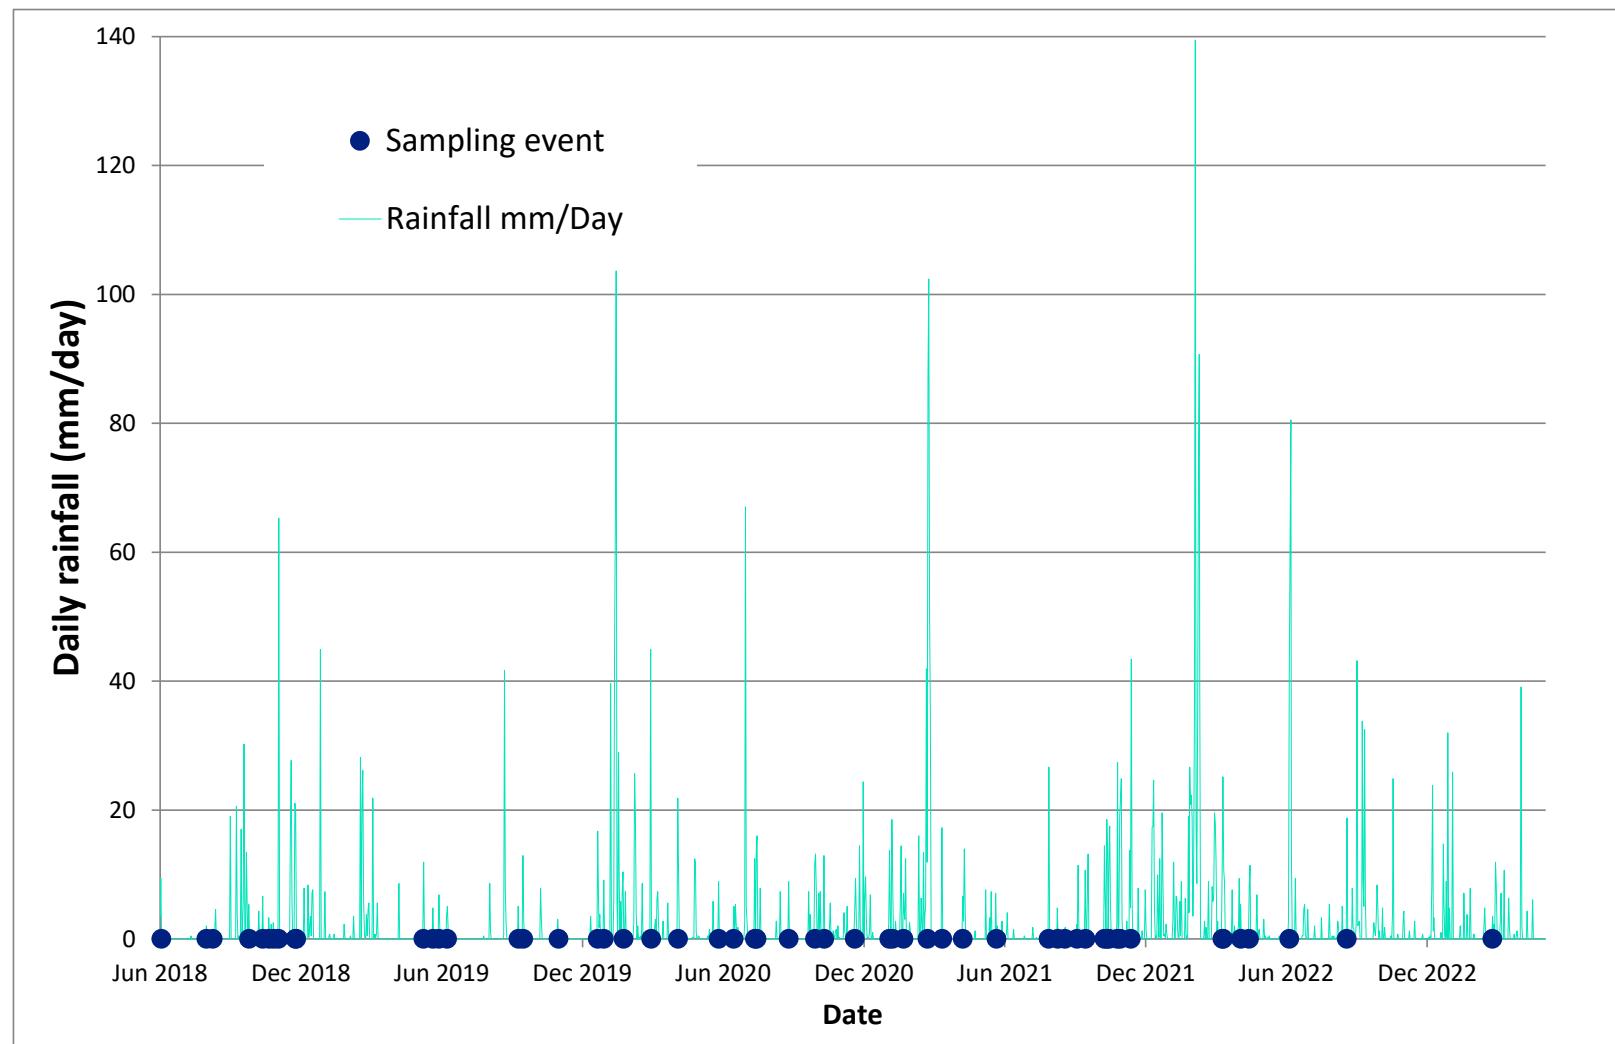
- ⌚ Monitoring from June 2018
- ⌚ 55 qualifying events
  - 1 to 64 hours sampling durations
  - 6 to 105 aliquots (x 2)
  - 0.5 to 282mm rainfall
  - up to 107mm/hour rainfall
- ⌚ 13 events with flow rate >5000mm/hr
